Assessment on causes of defect and the maintenance management practices on low cost building (A case study of Jimma Town Condominium)

Arif Awol, Dr.Ing. Tamene Adugna, Alemu Mosisa

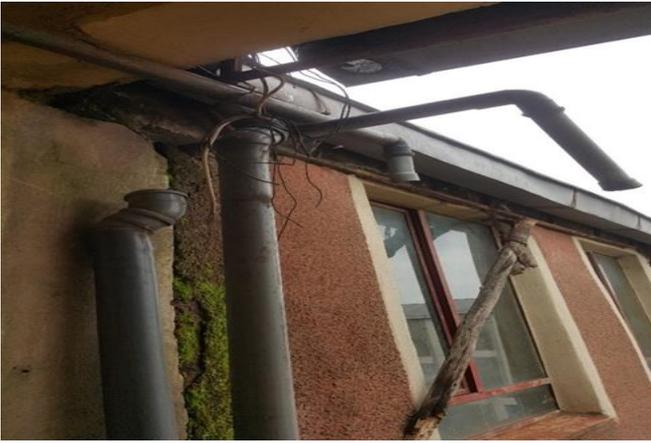
Fig 2. (a) Pipe leakage due to improper connection.

As it was ranked on table 2, Leaking of pipes was the top ranked type of defects. Leaking is water that seeps out from behind walls, under concrete slabs and asphalt, basements, landscaping, water intrusion in roofs, irrigation systems, and radiant heat system. The consequence of leaking is damp.

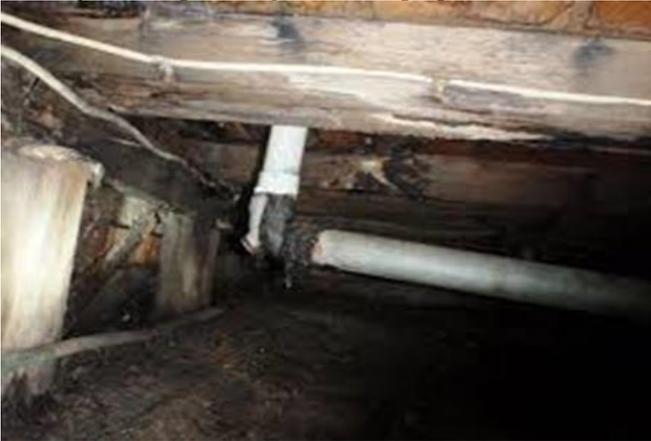
Fig 2. (b). Leaking of pipes in toilet

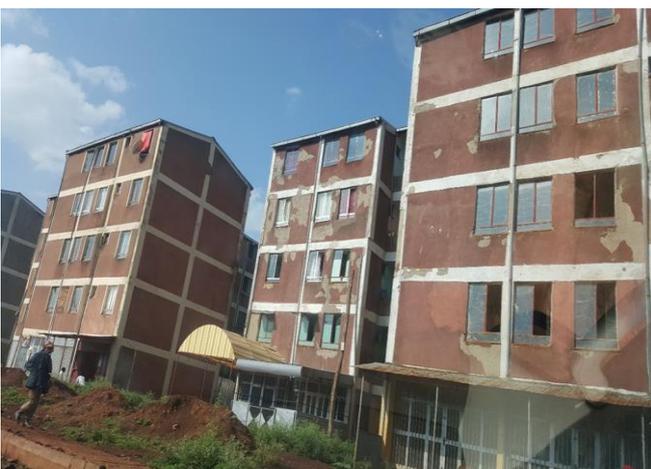
Fig 3. Peeling of paint on the wall (Saris site)

Peeling paint was the most common defect which was critically found on the building façade, especially on the plastered walls, ceilings, beams and columns. These components were consistently exposed to sunlight, rain, wind and dampness, resulting in peeling paint.

Paint peeling refers to paint that does not adhere to the surface. It can appear in a wide range of geometries. It is usually caused by incompatible foreign materials either in the paint or on the substrate, but can also be caused by incompatible substrate material, and occasionally improper paint application process control.

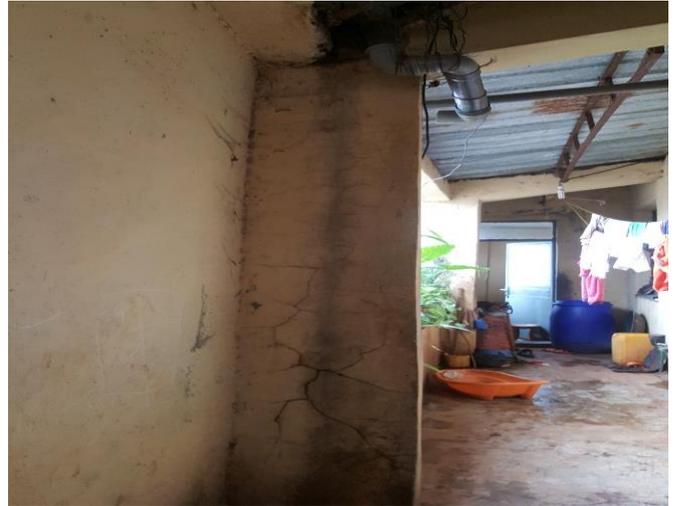
Fig 4. Cracking on the wall and Floor

Some parts of the inspected Jimma town condominium showed serious cracks while some only showed minor cracks. From the inspection, cracks in wall were in various directions and varying in width from cracks to 5mm or more. The cracks in plaster and other finishes affected the appearance of the structure but fortunately did not pose any safety concern. There were long and continuous cracks across the walls, beams, columns, ceilings and floors. Moreover, a diagonal crack was found at the corner of door where the crack tip was very thin with increased thickness at the initial point.

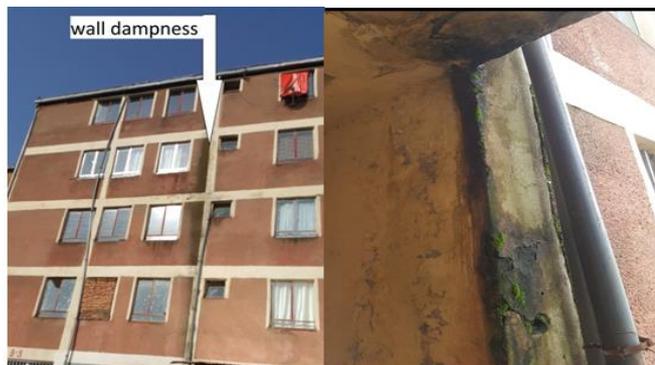
Fig 5. Wall dampness

Dampness can arise from unintended water caused by leaking pipes, gutters and flashings. The leaking water penetrated into the wall, resulting in horrible water stains. Under long term of dampness penetration and poor ventilation within the building, excessive moisture promoted the growth of mould on the surface of wall (Wang, 2011).

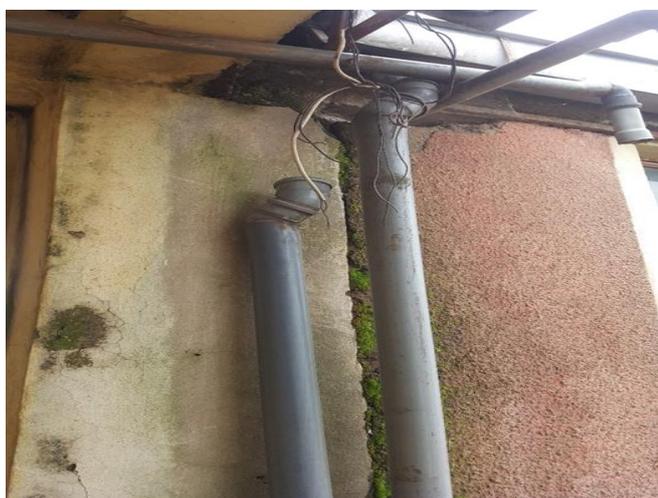
The growth of mould and fungi are ordinary consequences caused by excessive dampness. Mould and fungi will grow when they gain enough moisture and nutrients (Wang, 2011). However, the growth of mould causes a lot of problems to the school environment. It not only physically affected the appearance of the building structure, but also led to plenty of health illnesses to the students and staffs.

Fig 6. Mold and Fungi on the wall
