The false safety of three-wheelers: A study in the Sri Lankan Context

S D R Perera, I U Atthanayake

Index Terms—Three Wheeler, Sri Lanka, Safety, Crash worthiness.

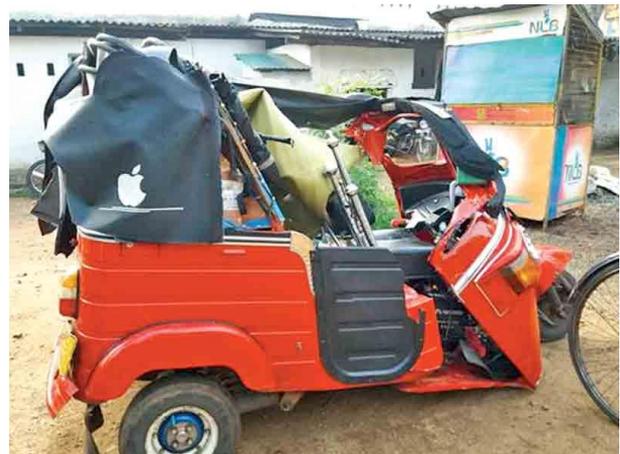
Fig.1 – Three wheeler crash case 1 [4]

The image depicts the crashing of the frontal part of the three wheeler into the driver compartment and severe damage to the hood. The analysis reveals that although the floor board of the three wheeler is strong enough to withstand loads, there is no protection at all from the hood. Further, there are no strong members to protect the passenger compartment and members in the front to absorb the crash energy.

A bus has been crashed onto a three-wheeler where the three wheel driver was killed on the spot while injuring a women who was in the three-wheeler [4]. Submit your manuscript electronically for review.

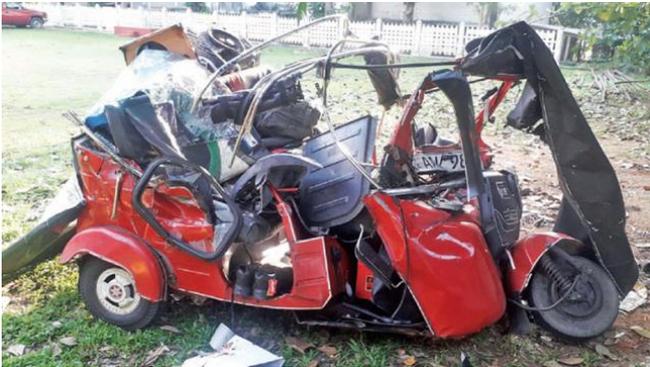
In this accident, all four people travelling in the three wheeler were killed when collided with a truck [5]. The wreckage clearly indicate the lack of a crumple zone to absorb the crash energy and lack of a strong hood cover and an A pillar to protect the passengers in a frontal collision is missing in the three wheeler. Had the three wheeler designed to accommodate the crash safety requirements, the fatality of the

accident could have been reduced and four lives could have been saved. The hood structure has been customized which was fabricated from stainless steel. However, even the new structure is not comparable to meet the requirements in terms of crash safety.

Fig.2 – Three wheeler crash case 2 [5]

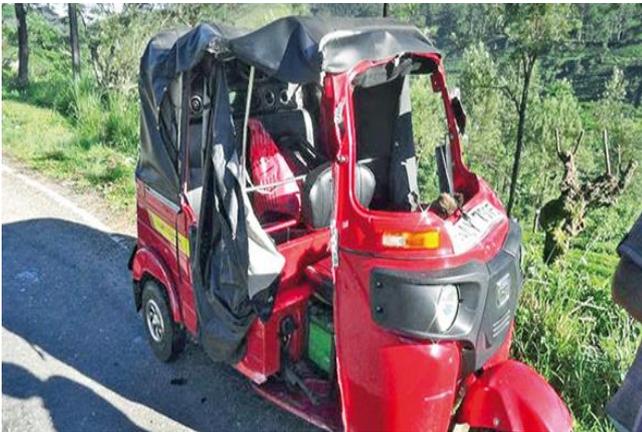
The case 3 is a crash on to the tank at the back of a cement carrying container due to loss of control by the three wheel driver. Three people were critically injured [6]. The image depicts that the frame of the three wheeler and hood are still intact due to the nature of the incident. However, injuring the occupants is a serious issue.

Fig.3 – Three wheeler crash case 3 [6]

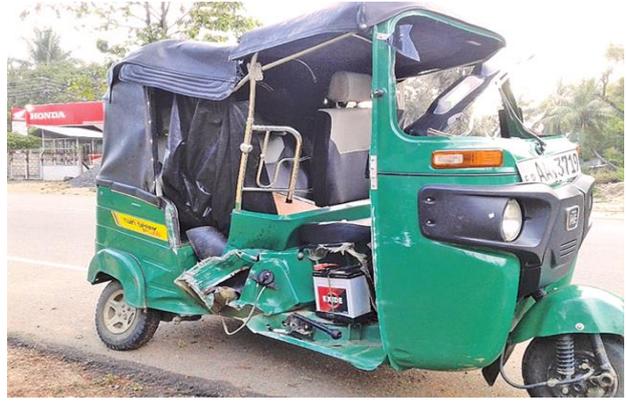
Fig.4 – Three wheeler crash case 2 [5]

The image depicts that the frame of the vehicle including the hood is intact and no major crush forces have been imposed on to the three-wheeler. However, severely injuring the passengers compared to the small damage to the three wheeler is a serious issue.

The case 4 is a three wheeler crashed onto a concrete post. Three people travelling in the three wheeler were severely injured.

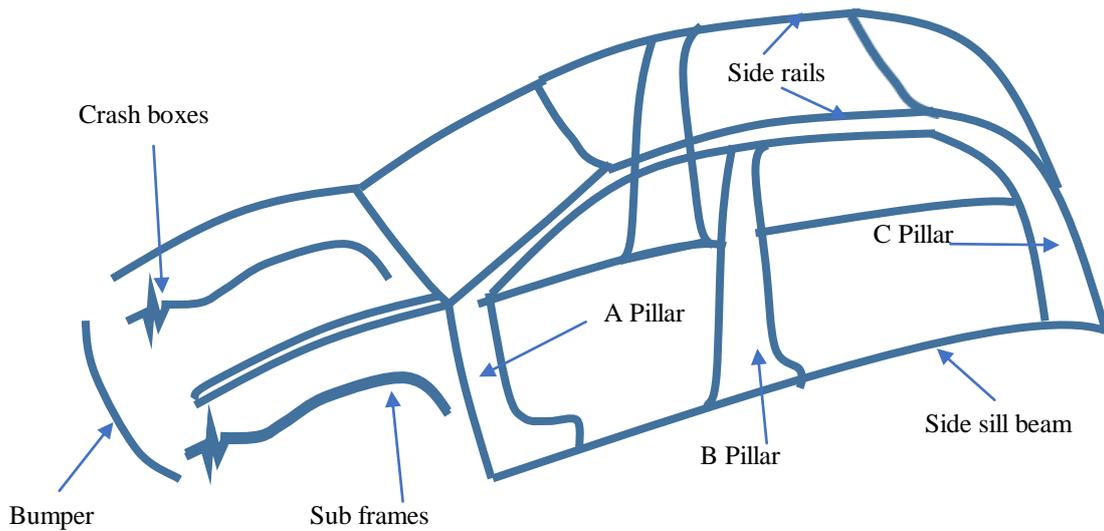
Protective shell to the passengers comprising of A Pillar, B pillar C pillar and side beams.

Fig.5- Structural designs of an automobile to ensure the crash worthiness

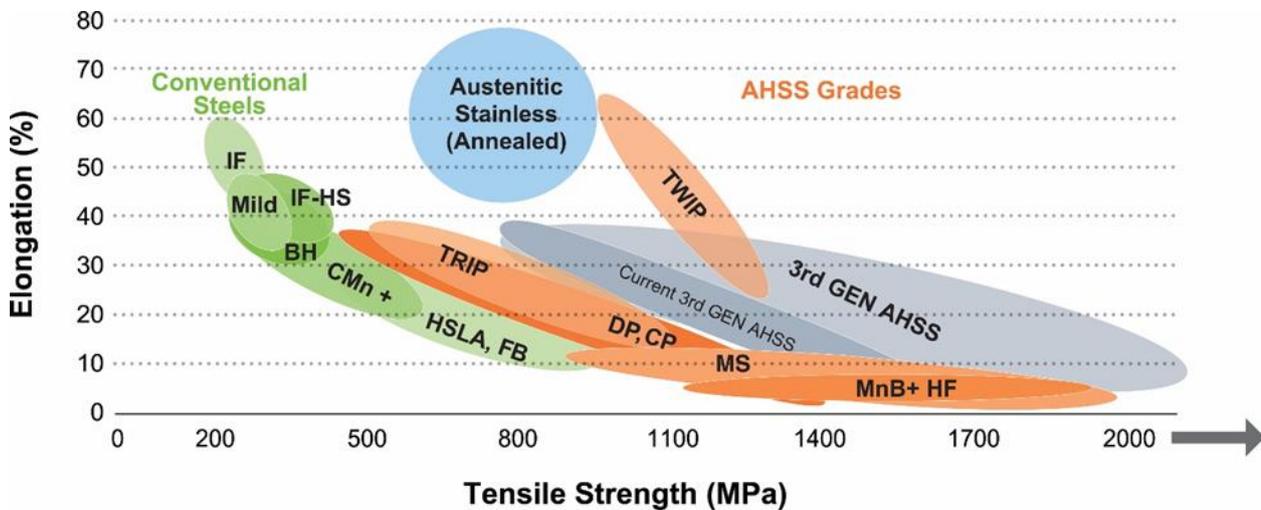
The common material used to construct the three wheel body and chassis is steel grade IS513 having yielding strength of 225 MPa [9] whereas Advanced High Strength Steels shown in Fig. 6 are being used in modern automobiles [10].

Fig.6 - Advanced High Strength Steels [10]

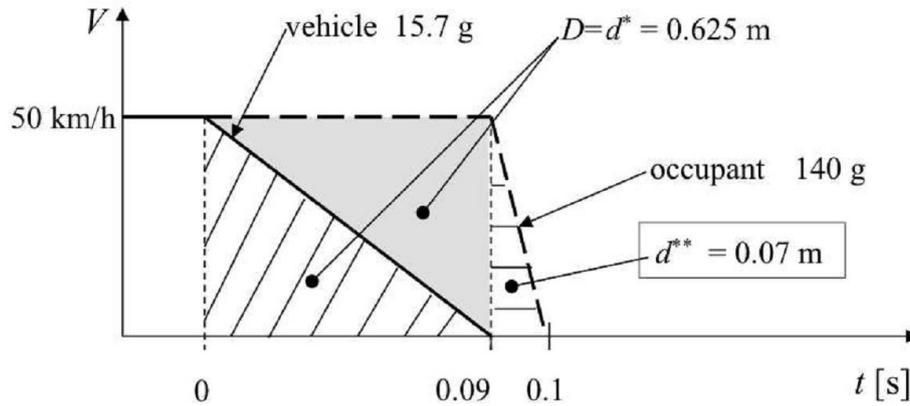
The two main restrain systems are the Airbag and the seat belt. The airbag is being activated during a collision whereas the seat belt is designed to restrain the occupants of the vehicle. The Fig. 7 show the Speed time diagram during a crash against a rigid barrier for Unrestrained occupant.

According to the Fig. 7, for a vehicle travelling at 50 km/h, during a crash against a rigid barrier, the deceleration of the vehicle would be 15.7 g, whereas the deceleration of the occupant is 140 g. If the passenger was restrained to the vehicle seat, the passenger would experience a deceleration of 15.7 g.

Figure 7 – Speed time diagram during a crash against a rigid barrier. Unrestrained occupant [11]

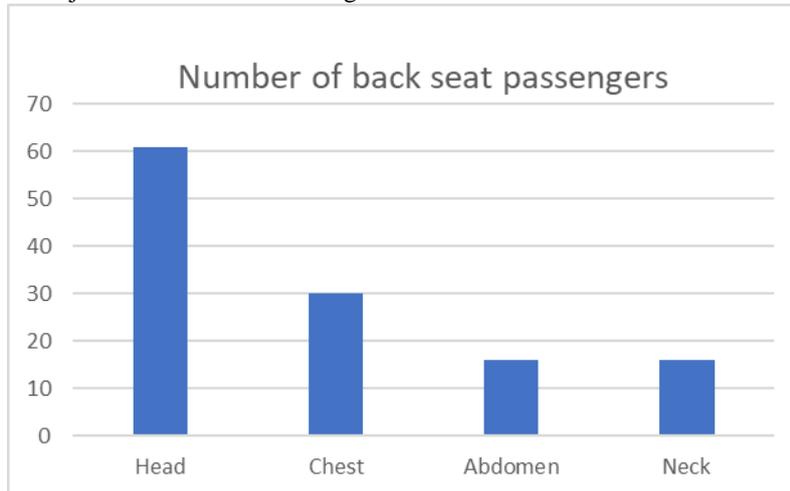
Adysinghe et.al [13] carried out a study based on medico-legal data available in three hospitals in Sri Lanka for occupants of three-wheelers succumbed from road traffic accidents. A total of 132 cases were studied including 57(43%) drivers and 75(57%) back seat passengers. The distribution of fatal injury site for back seat passengers and drivers are given in Fig 8. The site which caused highest number of fatalities is the head whereas the second was chest for both the driver and the passengers. As a percentage, the neck accounted for a total of 22.7 %.

Fig.8 - Distribution of fatal injury site for back seat passengers

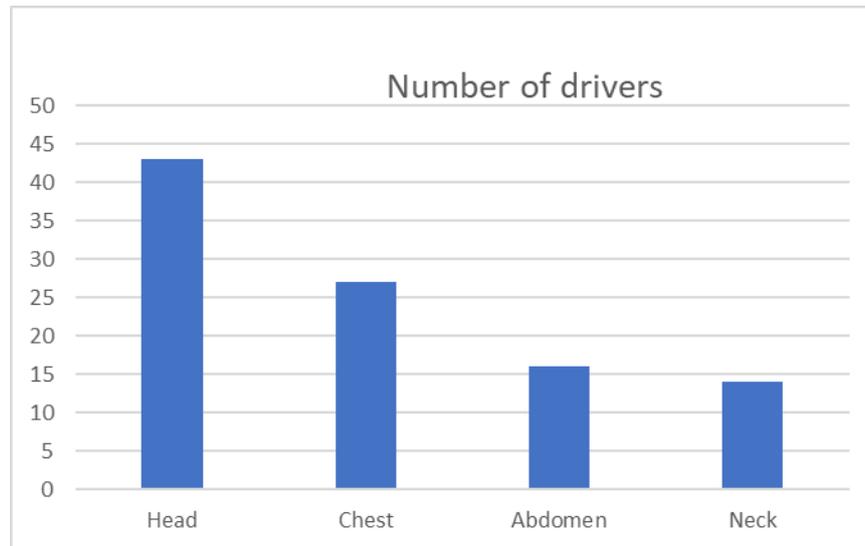
Fig.9 - Distribution of fatal injury site for drivers
